Reconstruction / Investigation

Motor Vehicle Collision

Date: October 25, 2010

Location: US-71 Highway North of Harry Truman Dr.

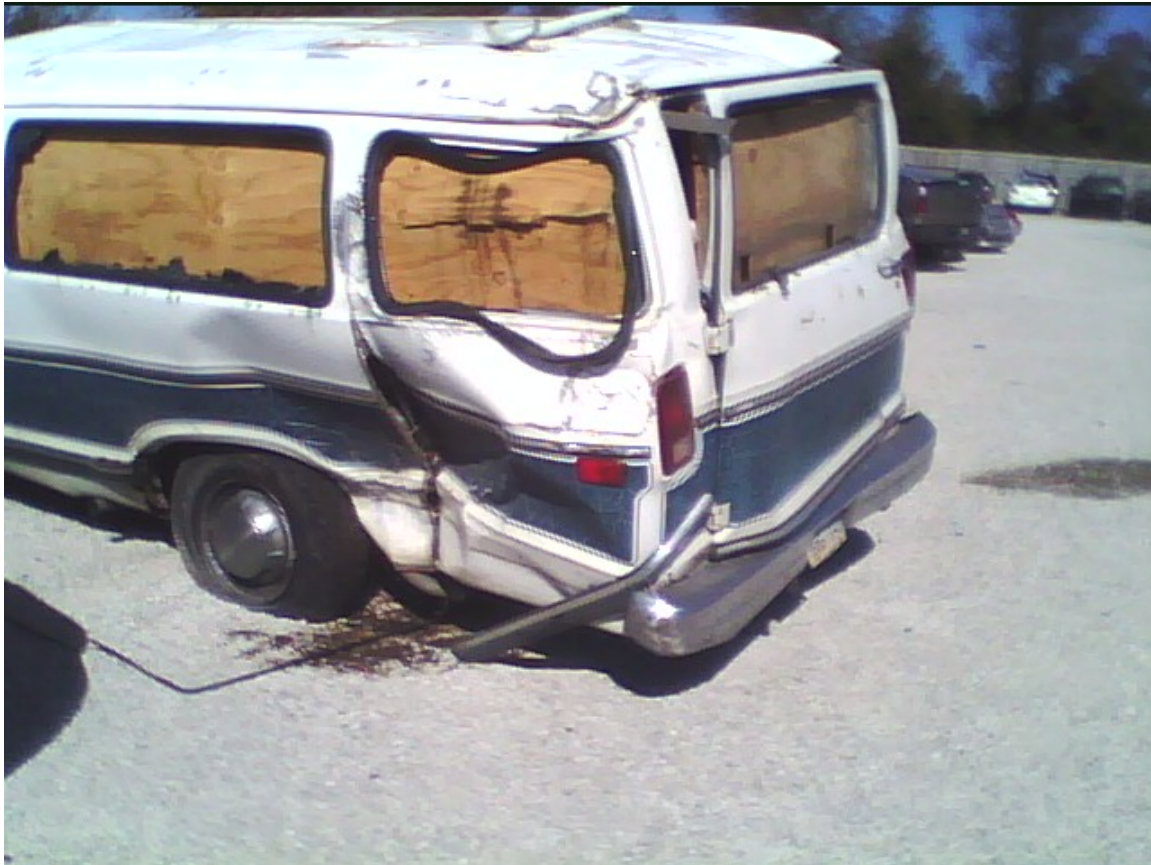
The Dodge suffered multiple contact damage points during the collision event. The first appears in Figure 1. The left rear quarter panel behind the left rear tire was struck as was the left rear tire and wheel.

Figure 1 Post Collision Supplied

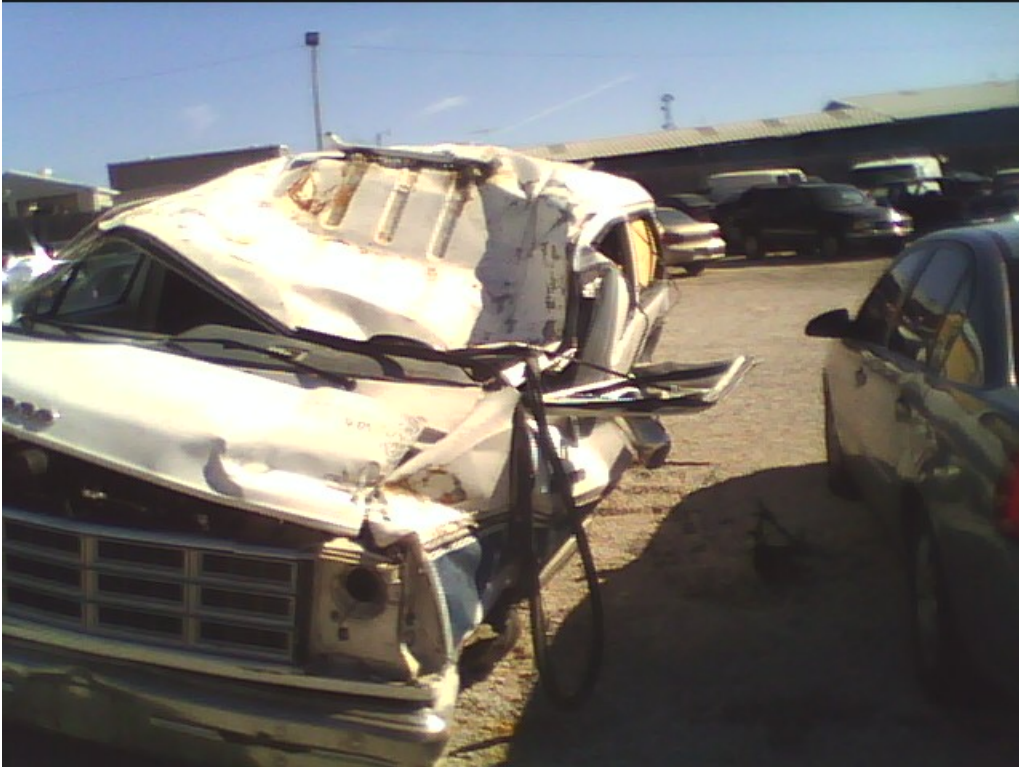
During the roll over the top and side made contact with the barrier wall in the center of the roadway. See figure two.

Figure 2 Roll over damage

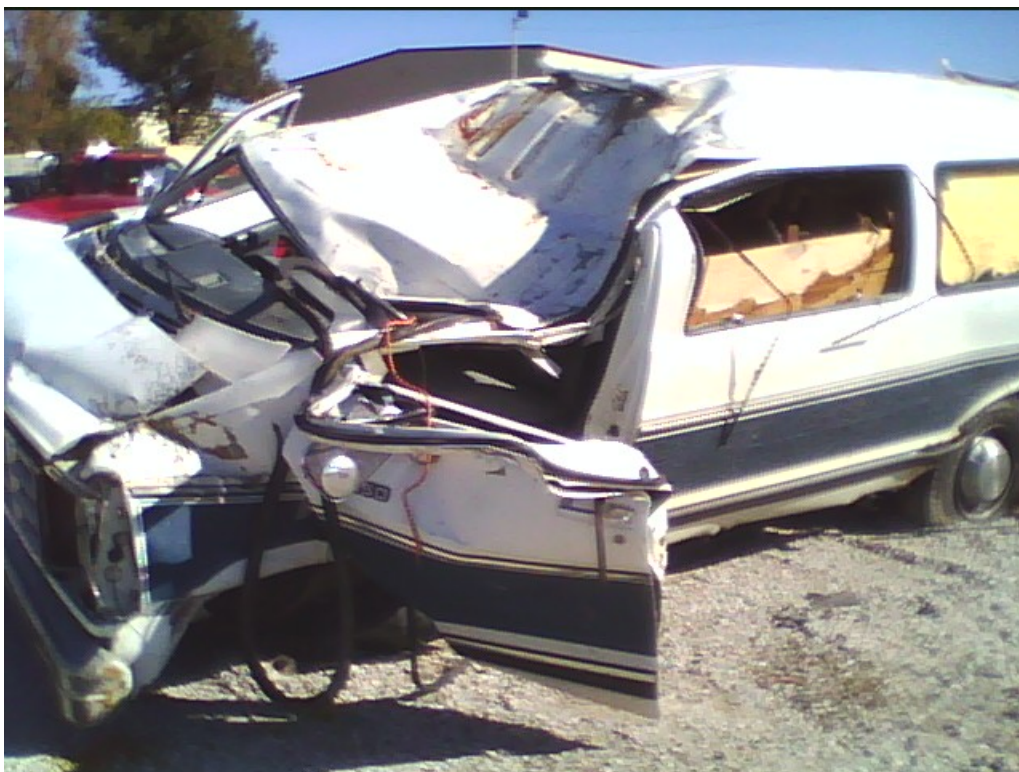
Due to the police report indicating the left front corner of the van struck the barrier wall figure three is examined. I observe contact damage to the top of the van hood that occurred as the van rolled onto the barrier wall. I do not find any contact damage consistent with a barrier wall contact to the left front fender or bumper. There is no displacement of the bumper and no paint damage detectable. Significant induced damage is evident from the roll event to the top and fender.

Figure 3 Left front of Dodge van

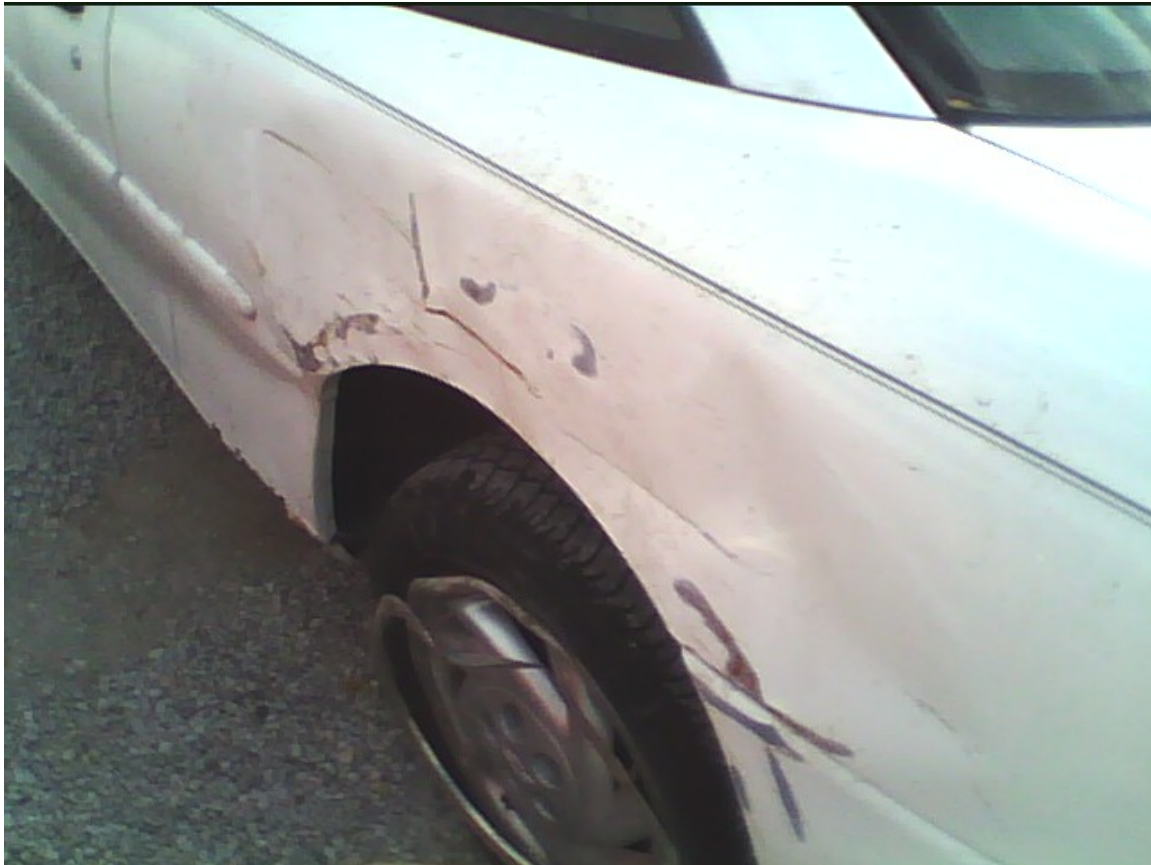
The Chevrolet suffered multiple contacts as well. In figure four the left rear tire wheel and fender suffered damage. This damage is consistent with the barrier wall contact observed in the at-scene photographs recorded by the police. The grind marks around the wheel well opening are characteristic of contact with the concrete barrier wall.

Figure 4 Left rear Chevrolet

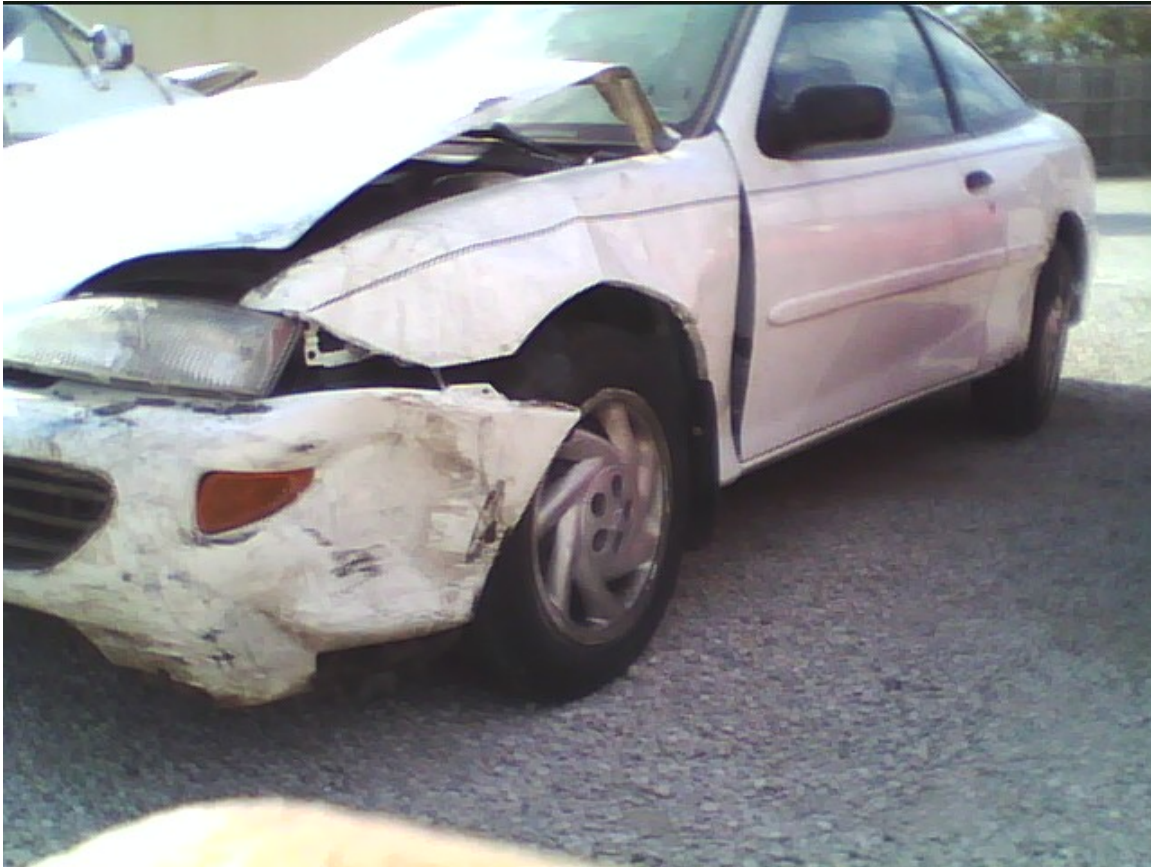
In figure five, the left front corner of the Chevrolet is visible. Contact damage is visible to the cosmetic bumper cover, right side leading edge of the hood and left front fender. This photograph and additional supplied photos document the presence of blue paint transfer that appears consistent with the Dodge van.

Figure 5 Left front Chevrolet, Blue paint left front of Hood

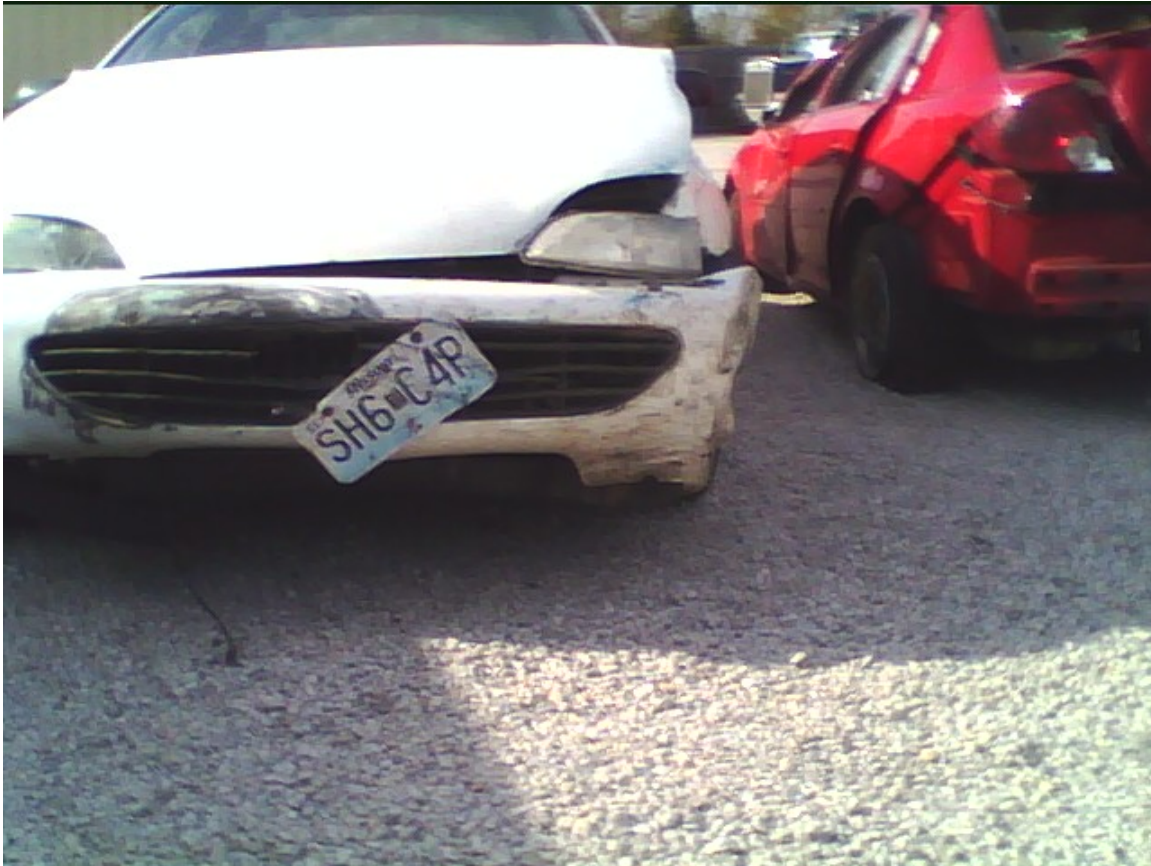
Figure 6 Chevrolet front tire contact and blue paint.

Figure six depicts the final contact between the front bumper of the Chevrolet and the left rear tire of the van. The dark circular pattern left of the front license plate is caused by the outer edge of the van tire rubbing against the bumper.

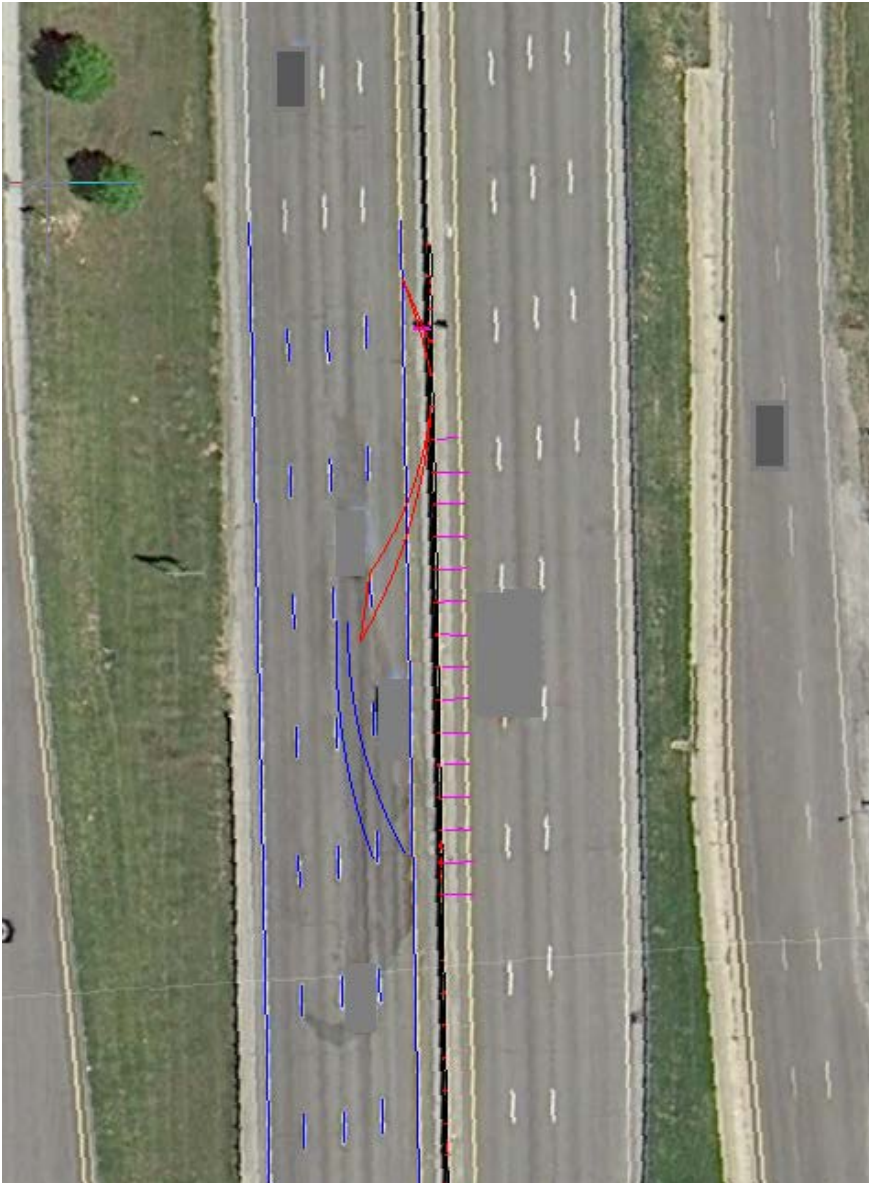
Figure 7 Crash site reconstruction

Post-crash the site was mapped detailing the contact and fracture damage to the concrete barrier that appears in the scene photographs and are present at the crash site. Using the Supplied photographs and a historical aerial image the tire mark evidence was reconstructed. See figure 7.

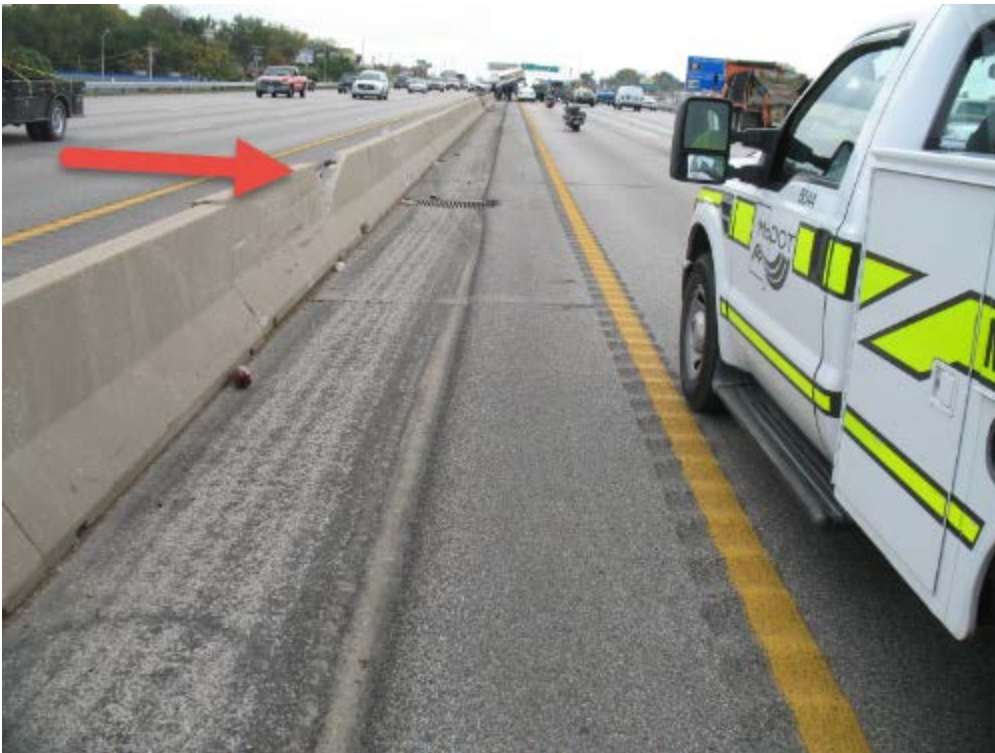
Figure 8 Police IMG 3519

A unique fracture is observed in the barrier wall near the initial wall contact.

Past the fracture that is believed to be preexisting, a set of time marks go left of the yellow fog line. The tire marks cross a draining grate and lead to contact with the wall. The wall contact damage is consistent with the left rear tire and damaged fender of the Chevrolet.

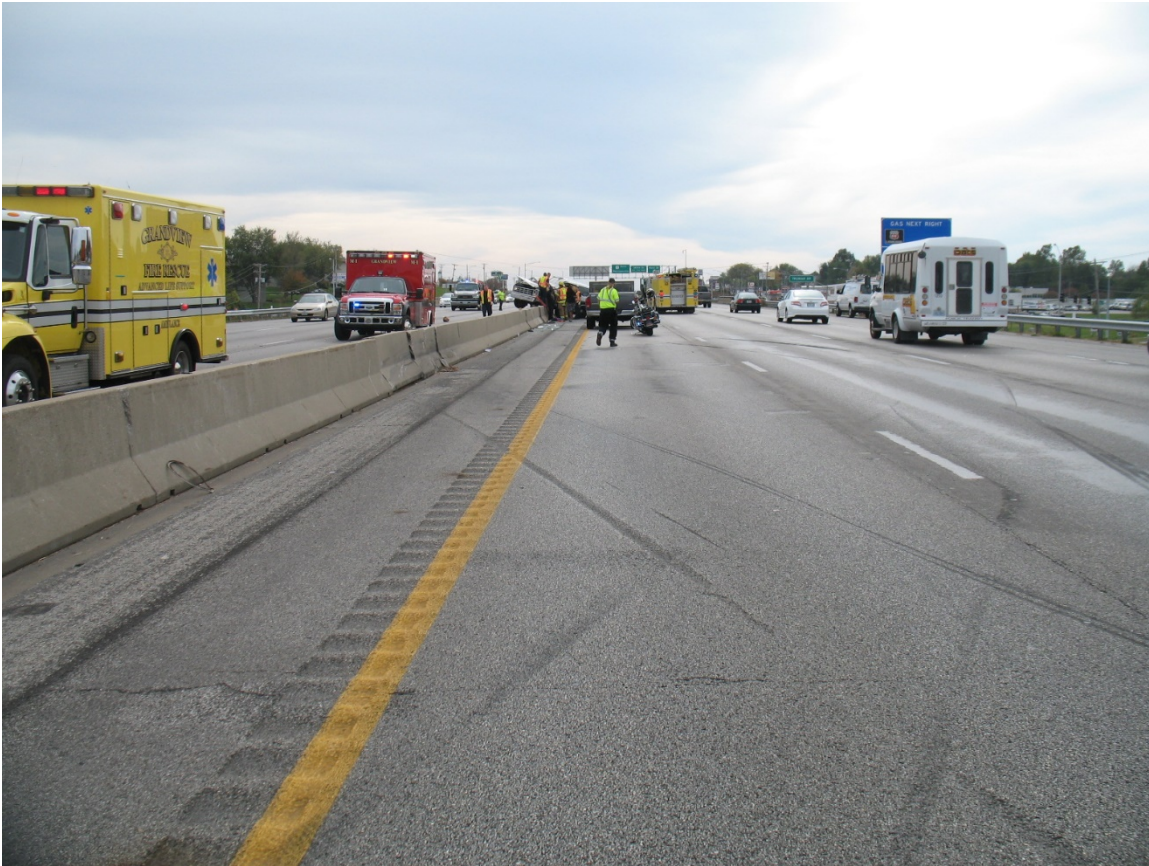
Figure 9 Police IMG 3502

In figure 9 the tire marks can be observed back on the traffic lanes and entering the number two southbound lane. As the left front of the Chevrolet crosses near the lanes line and into the number two lane a distinct directional change is observed. This tire mark is commonly called a “Crook” and is indicative of a vehicle that has had a force applied from another object and subjected it to a change in direction.

In image nine a straight set of tire marks lead from the number two lane across number one and into the barrier wall. These marks are not connected to this event. These marks are accompanying gouge marks in this direction. Neither the Dodge nor Chevrolet depict a condition where these types of gouge marks could be made.

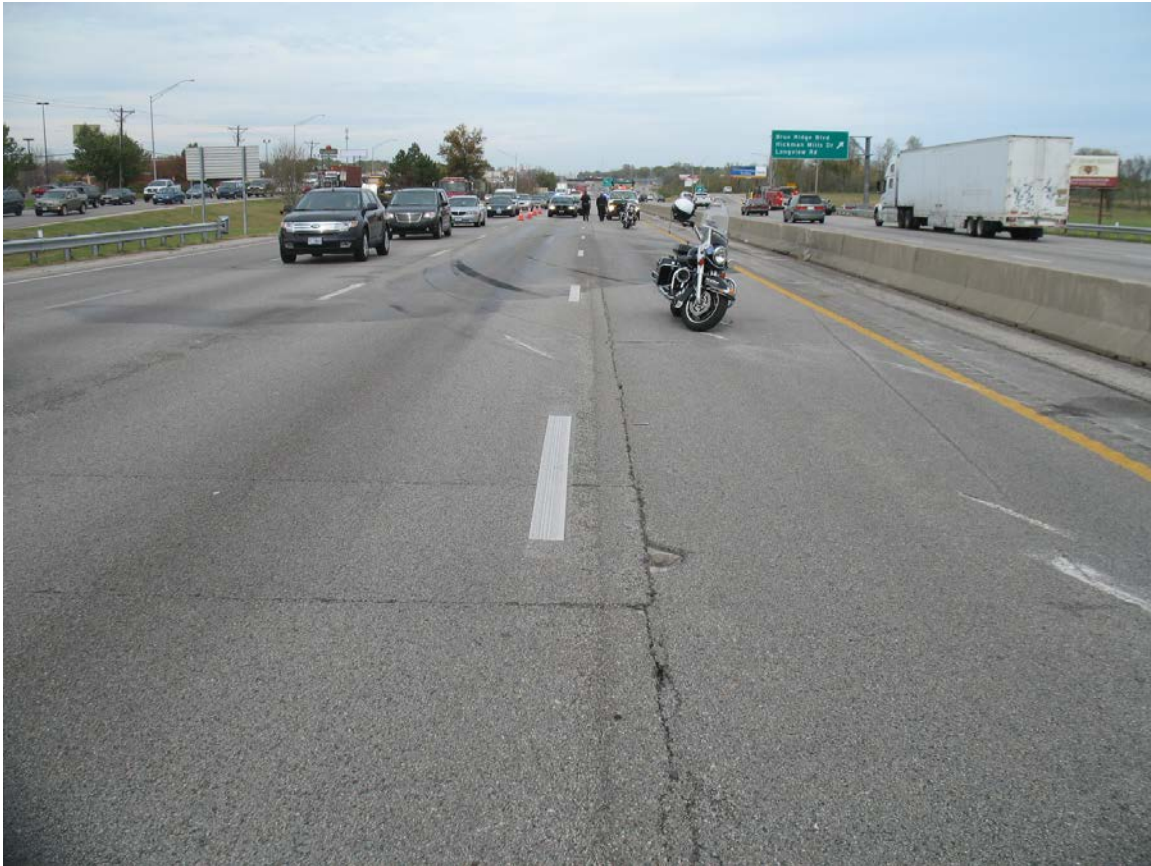
Figure 10 Police IMG 3514 Looking north

In figure 10, the counter clockwise rotation of the van can be witnessed by the curved tire marks. These marks cease just to the left and behind the parked motorcycle. This is the trip point for the van and are followed by ground contact before the van flips atop the concrete barrier.

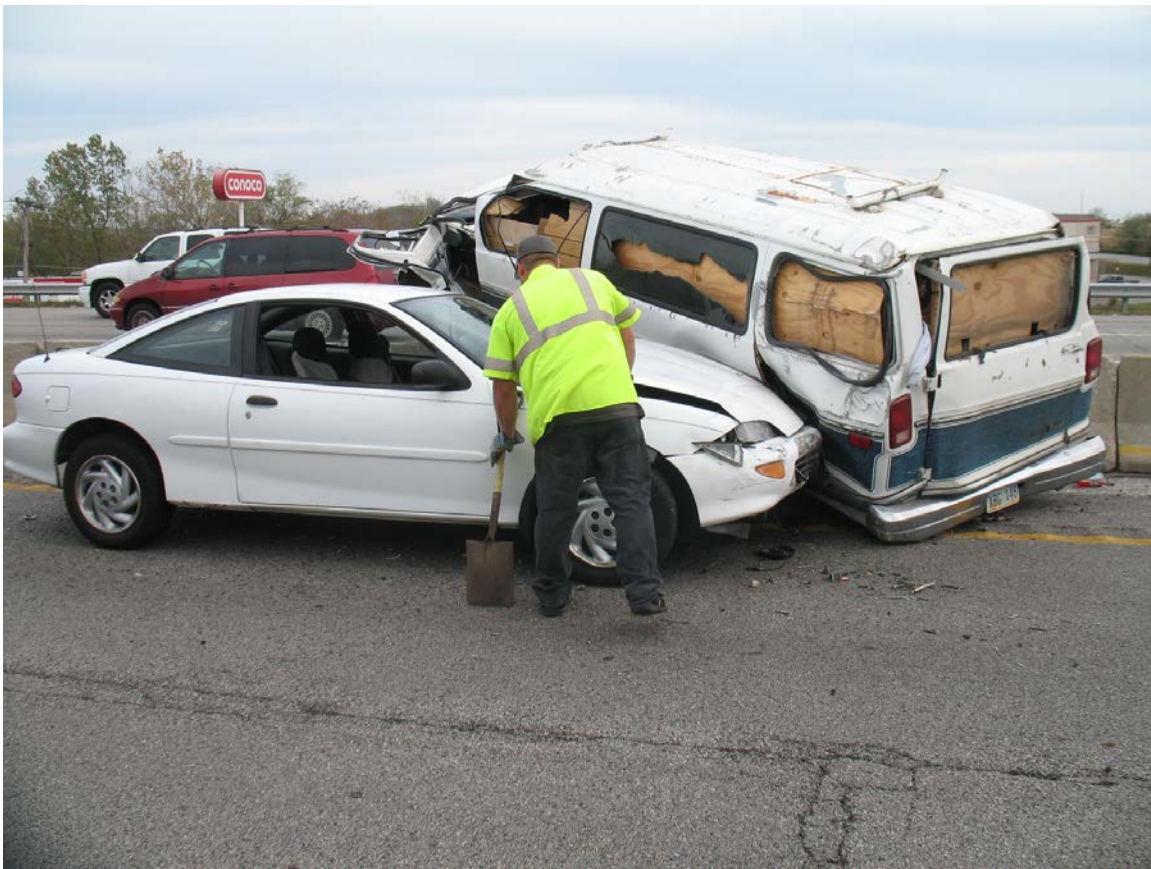
In figure 11 the final rest of the vehicles are memorialized.

Figure 11 Police IMG 3516 Final Rest.
